**Swimming Pool Audit
for the
City of Oak Ridge, Tennessee**

Counsleman • Hunsaker
AQUATICS FOR LIFE

March - 2016

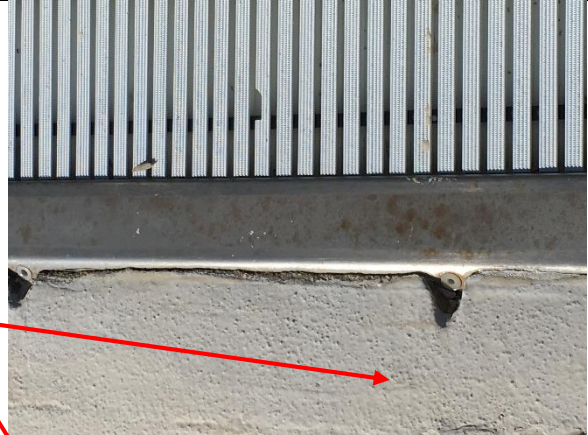
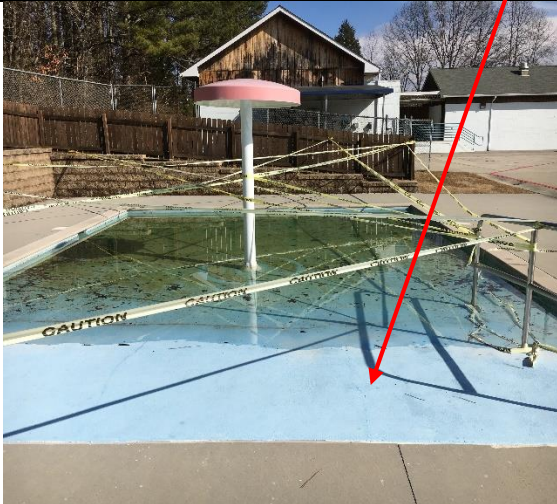
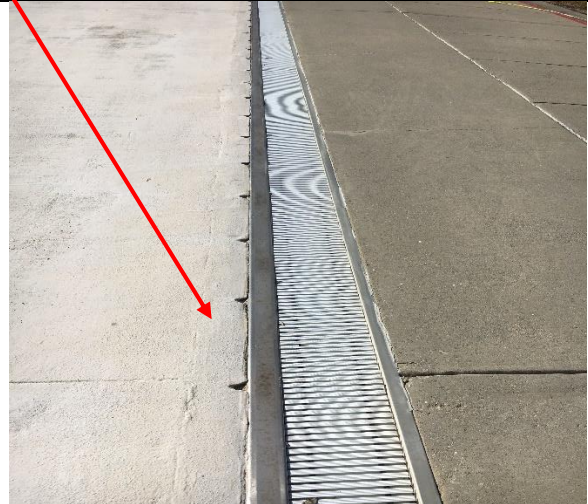
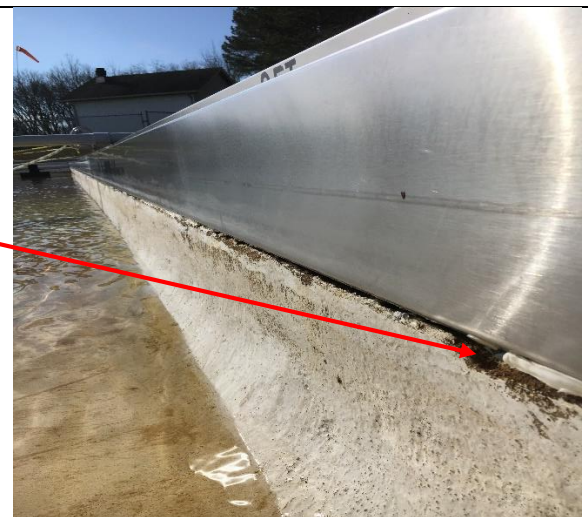
At the time of my visit and review both pools were full of water and a majority of the pool surfaces could not be observed. However, it was relayed to me that 1/3 of the Main Pool is painted each year.

Important Note: Staff relayed that they had no knowledge of the pool surface ever being sandblasted prior to re-coating.

Typically, stainless steel gutters have a 1" to 2" grout joint between the bottom of the stainless steel and the concrete wall. This is utilized for leveling the gutter during installation. It appears the gutter is resting directly on concrete which does not provide proper seal. The area shown on the picture to the right indicates separation and likely a primary leak source for the pool.

- a) To clearly identify the structural integrity of the pool shell, it is recommended to have the pool surface sandblasted and cleared of all finishes and coatings. This would reveal imperfections, cracks and deteriorated concrete allowing for a clearer analysis of the structure. It is recommended to contact a structural engineer to perform this additional analysis.

- b) All pool construction joints should be cleaned and cleared of all old caulk and foreign materials. This joint should be properly prepped and re-caulked with a chlorine resistant sealant.

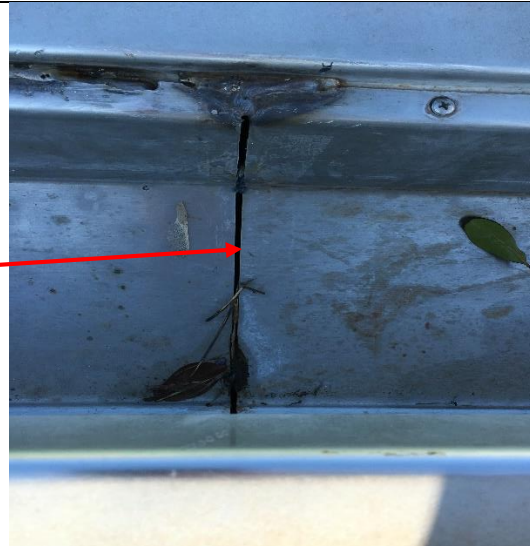
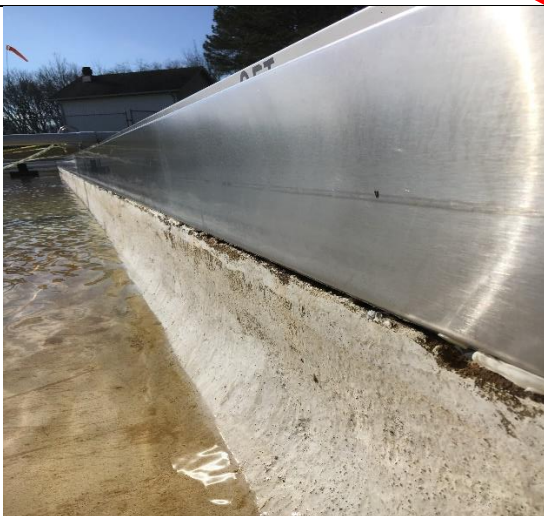
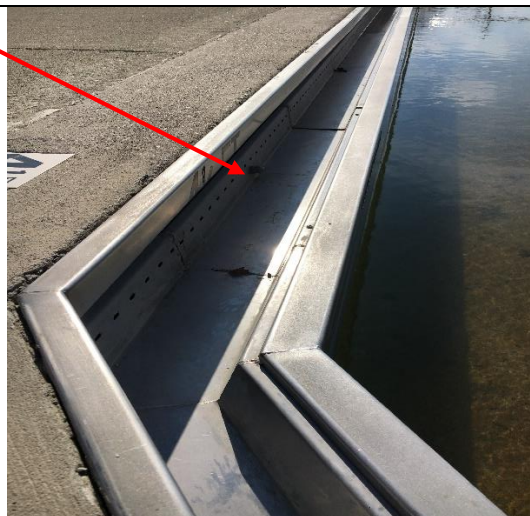
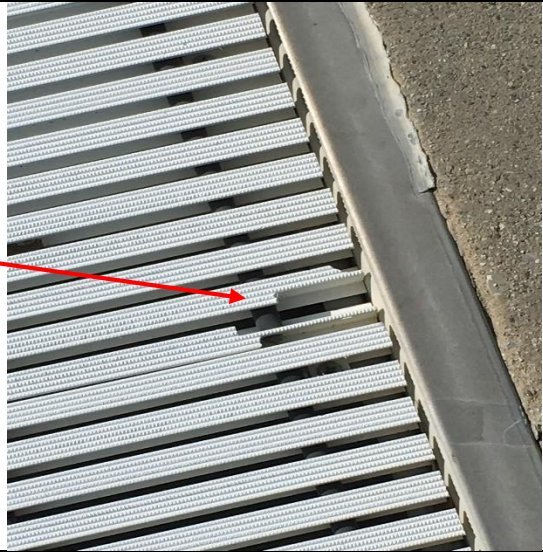
The stainless steel gutter is showing signs of its age. Mild corrosion exists but is to be expected. However, there are areas of the gutter where movement and separation have taken place. It appears there have been attempts to weld the gutter to limit future movement, but gaps have opened limiting the design purpose and effectiveness of the gutter system.

Other than the zero entry area, there is no gutter grating in place. I suspect when the gutter was installed grating was provided for the entire perimeter of the gutter system.

| <p>Where gutter grating does exist, there are numerous locations where the gutter grating is fractured and splintered. There are other areas where the grating is not properly mounted to the gutter making it loose and vulnerable to additional damage.</p> | |

- a) New gutter grating should be installed on the entire gutter system. Although Tennessee State Health Code does not dictate this requirement, it is highly recommended due to safety concerns.

- b) The stainless steel gutter system needs to be isolated and pressure tested. There are numerous locations where joints have opened and attempts at welding have taken place. It is likely that this process will need to be performed by a representative of the manufacturer.

- c) The bottom of the stainless steel gutter that rest upon the concrete needs to be sealed. This is noted in the “Structure and Finish” portion of this report.

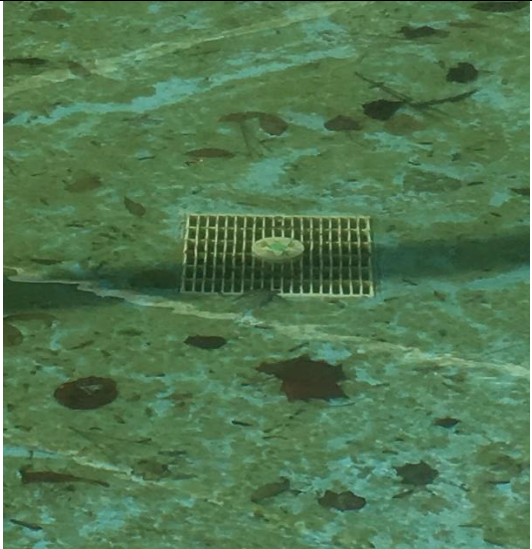
| <p>At the time of my visit the main pool and the kiddy pool were both full of water. The kiddy pool drains were viable but a physical inspection could not be performed. Staff relayed that the main drains had been retrofitted to meet federal and state guidelines pertaining to VGB (Virginia Graeme Baker Act).</p> <p>Under the law, all public pools must have ANSI/ASME A112.19.8 performance standard, or the successor standard ANSI/APSP-16 2011 compliant drain covers installed and a second anti-entrapment system installed, when there is a single main drain other than an unblockable drain.</p> | |

- a) Pool main drain sump VGB compliance documentation must be kept on file and readily available.
- b) Verify that all main drains screws, grates/covers are secure and in place before filling the pools. If any of the above noted items are missing or damaged they must be replaced with original VGB compliant parts.

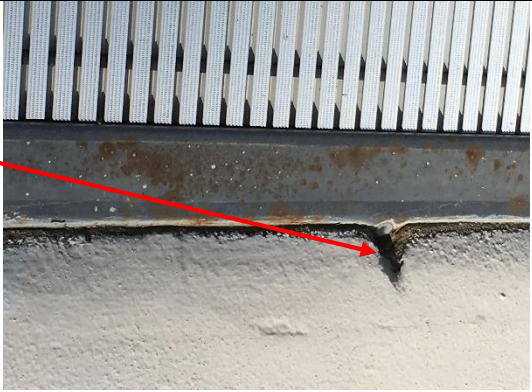
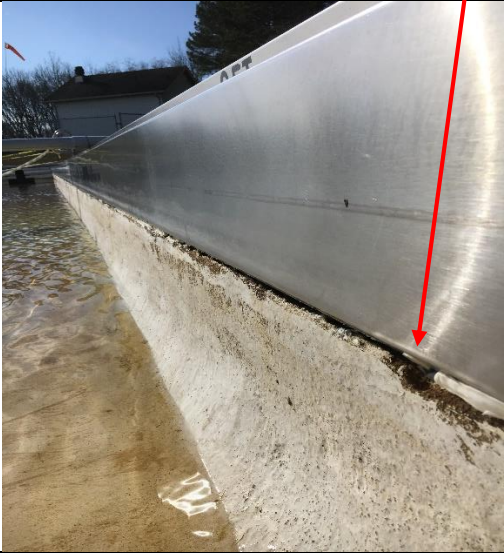
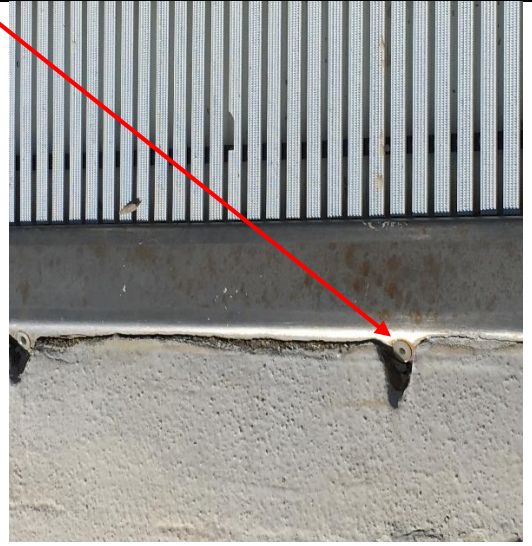
| <p>Main pool utilizes a pressure tube built into the stainless steel gutter system. Filtered and chemical treated water is returned to the pool through this pressure tube roughly 10 to 12” inches below the water surface. The as-built drawings do not indicate any further inlets.</p> <p>It has been noted that the deep water into pool often times becomes cloudy. The lack of filtered water being introduced to the deeper water can contribute to this issue.</p> | |

- The stainless steel gutter pressure tube and pressure piping needs to be pressure tested to verify there are no obstructions or leaks keeping the recirculation system from functioning as originally designed. If leaks are found they need to be repaired and then retested.

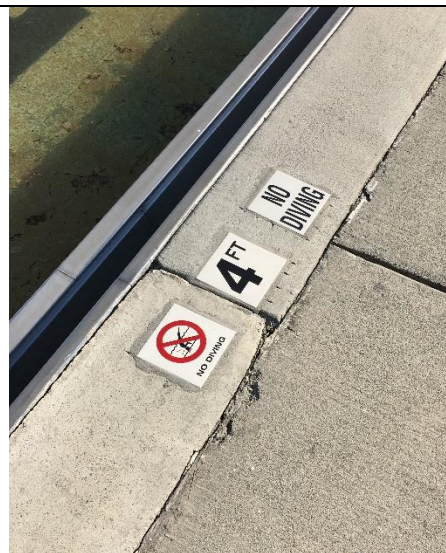
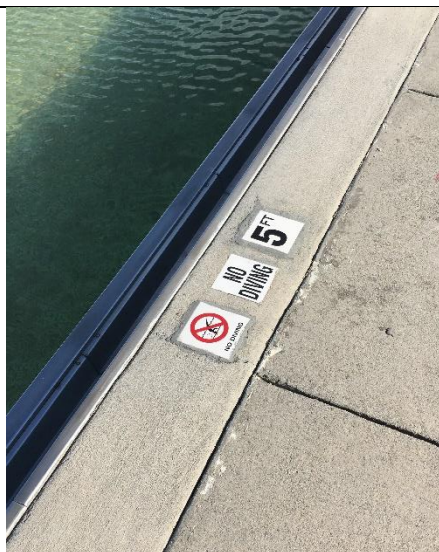
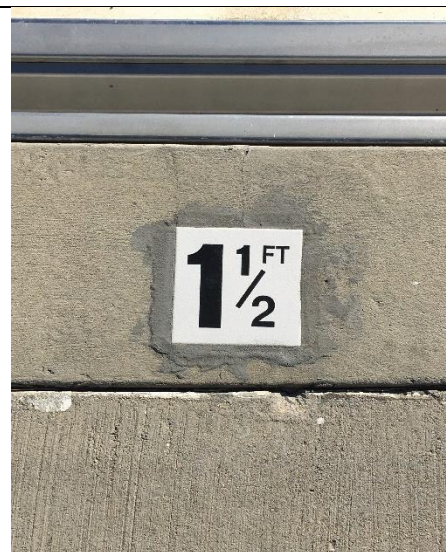
The main pool tile depth markings on the pool deck appear to be spaced beyond the Tennessee State Health Dept. requirements,

No diving markings should be placed in all areas were water depth is 5 feet or shallower.

- a) Below is the current Tennessee State Dept. of Health Code requirements for depth markers and warning signs. The depth markings and warning signs on the main pool need to be updated to meet state code requirements.
- b) Depth Markers: Tennessee Department of Health requires both “horizontal” and vertical depth markers as noted below. Currently the main pool is deficient of vertical

depth markers and many deck depth markers and warning signs. New vertical depth markers should be added to the stainless gutter system per the requirements below. The kiddy pool has no depth markers at all. Both vertical and horizontal depth marking need to be added.

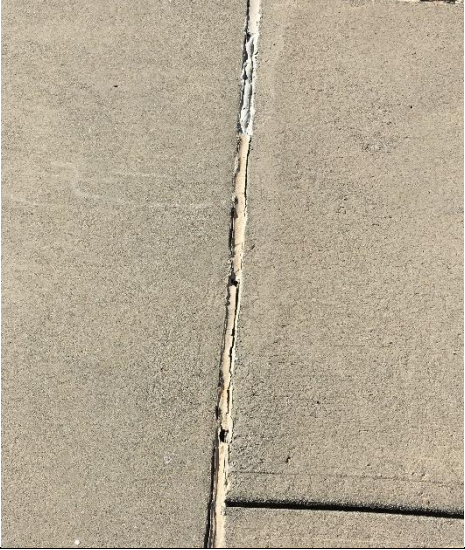
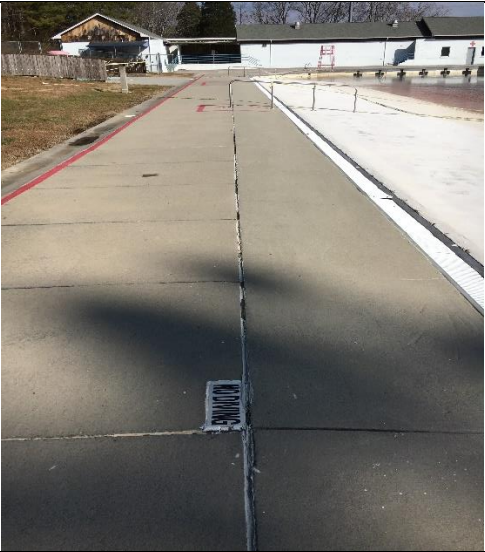
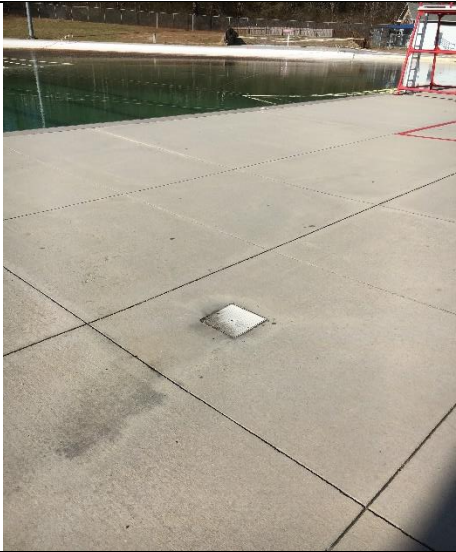
| <p>The pool decks appear to be in good shape. No significant cracking, heaving or skinning has taken place.</p> <p>There are numerous areas where the deck caulking has failed and needs to be removed and replaced.</p> <p>There are areas where the stainless gutter meets the concrete deck that caulking is absent.</p> <p>Per Tennessee State Health Code pool decks are required to slope “away” from the pool.</p> | |

- a) The pool decks should have all dilapidated caulk joints removed, cleaned and replaced. This will drastically decrease the ability of water the penetrate the pool deck area and potentially undermine the deck sub base.

- c) Pool decks are not allowed to drain into the pool. A deck drainage system is required unless the deck is properly sloped “away” from the pool edge. As noted previously in this report. Tennessee State Health Dept. may wave this requirement considering the age of the facility.

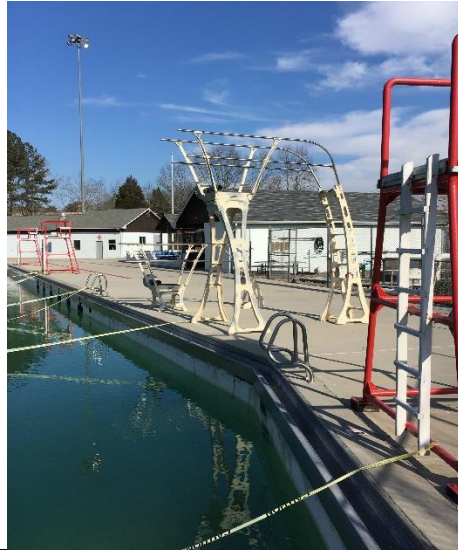
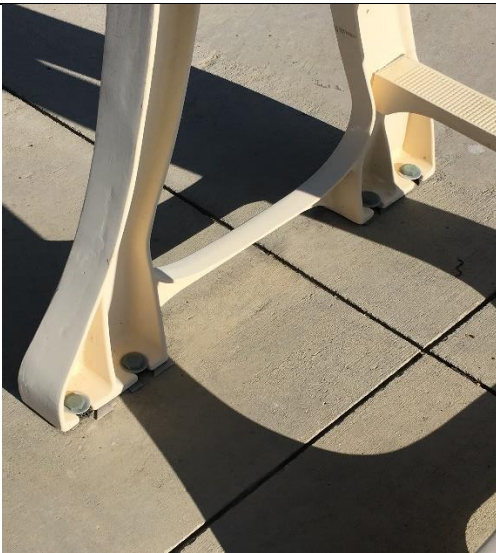
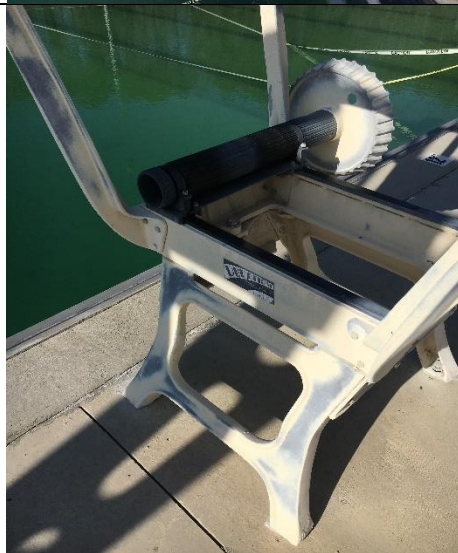
Currently there is one 1-meter dive stand and one 3-Meter dive stand located in the deep portion of the main pool. The spring boards have been removed as part of the winterization process. The durafirm stands appear to be in good working condition. Although signs of wear are visible.

Pool “depths” do meet Tennessee State Health Code “minimum” requirements. However, state code also “recommends” that that pools with diving facilities be designed in accordance with standards promulgated by FINA, NCAA, or U.S. Diving, Inc.

- a) Per current industry standards and national regulatory diving standards, there are portions of the main pool dive area that do not meet required pool slopes for 3 meter diving. Please refer to the charts shown below listing the dimensional national

standards for 1 & 3-meter dive stands. Dimension “D” shown below is noted as 33’-0” per As-built drawings. Regulatory standards require this dimension to be 33’-8”.

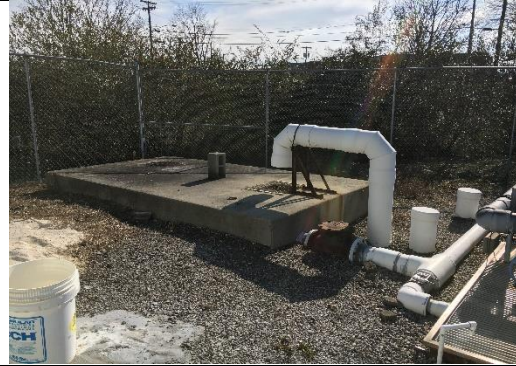
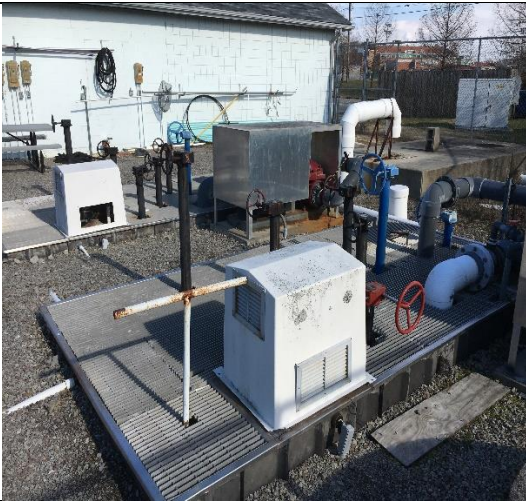
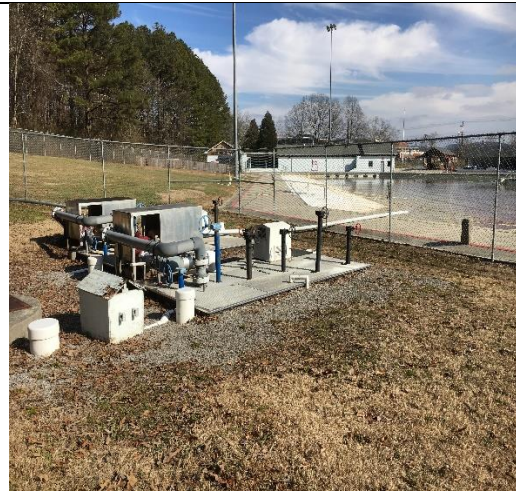
Very little of the pool piping is exposed for observation. It appears all of the pool piping is all Sch. 40 PVC.

Pool staff relayed that they are not certain if the main pool is losing any water due to the water replacement by the natural spring.

- a) Pressure test all pressure and suction pool piping. It is recommended to use a testing method utilizing helium as the tracer gas. To Locate a Leak, pipes are pressurised with helium and the operator uses a Sniffer Probe connected to the inlet of the leak detector. If the pipes lose pressure the probe is inserted into the soil at or near the underground pipe locations pinpointing the location of the leak.
- b) If piping leaks are found it is imperative that they are repaired and that the piping is re-tested to assure that all leaks are addressed. Excessive loss of water can result in undermining of the pool structure and/or surrounding decks. Additionally, chemical costs can spiral out of control.

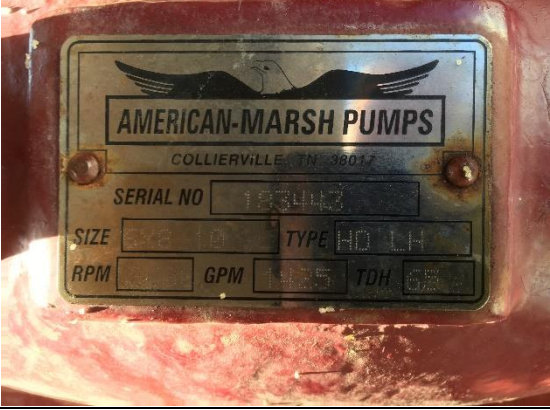
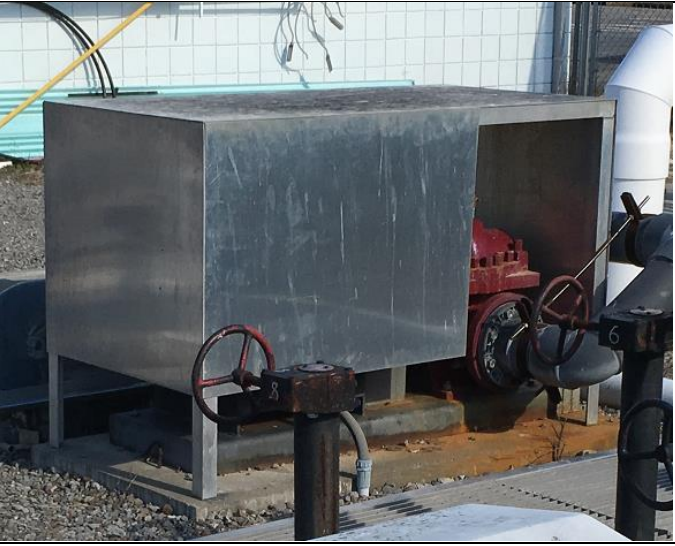
| <p>Pool staff relayed that all pool recirculation pumps were replaced in 2011.</p> <p>New pool pumps meet flow, TDH and RPM requirements of the original pumps shown on as-built drawings.</p> | |

- a) The pump and motor should be lubricated and oiled per manufactures recommendations. Typically at the end of each swim season the pump and motor is serviced and lubricated. At least once a month it is wise to bump the motor for a second or two to lubricate the internal components to avoid seizing.

- b) All Recirc. Pumps should to have a compound gage on the suction side and a pressure gage on the discharge side of the pump. This is utilized to determine if the pump with running within its designed parameters

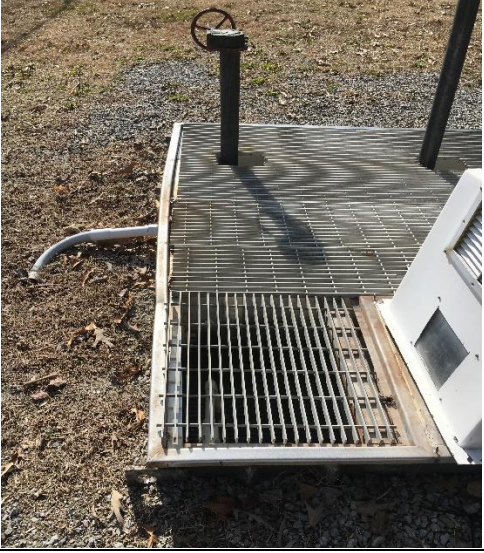
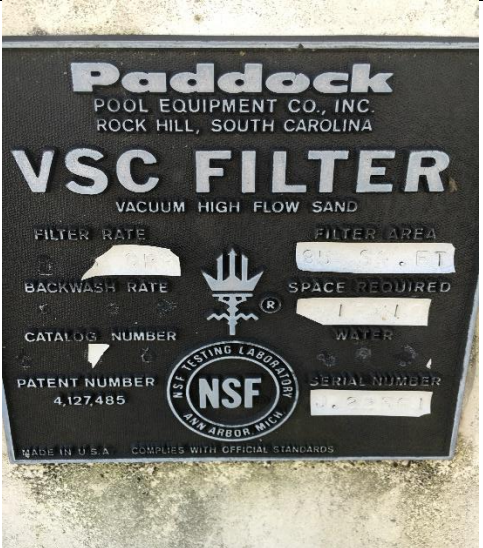
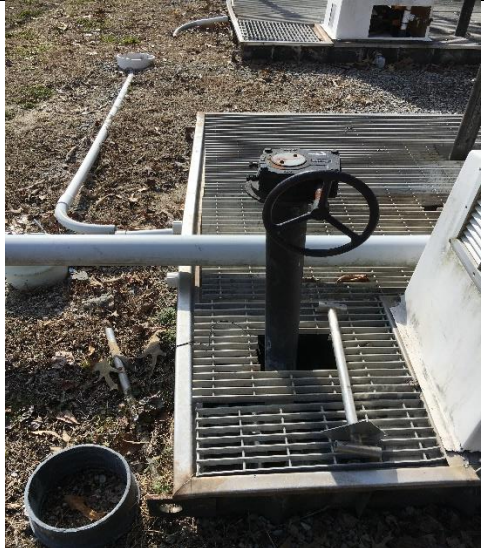
| <p>At the time of my review the filters were full of water, therefore my inspection was limited. Pool staff relayed that filter sand was replaced in 2007.</p> <p>It appears the filter are slightly deformed. This can be contributed to a number of potential causes. The likely cause is keeping water within the filters during the winter months.</p> <p>Filter sand bed depths should be verified. Refer to manufacturers recommendations.</p> | |

- a) It is recommended to confirm the filter gravel and sand bed depths. Commonly there is first a layer of gravel then a layer of sand 18" to 24"thk. Confirm required thicknesses with manufacturer prior to replacement.

- b) The filter sand was replaced in 2007. As we approach the 10-years with year round exposure, it is suggested to replace the sand and gravel. This would simplify valve replacement also.
- c) Once the filter sand and gravel is removed, careful inspection of the filter structure is needed. It is suggested to have the manufacture review the tanks and verify if any remediation is needed.

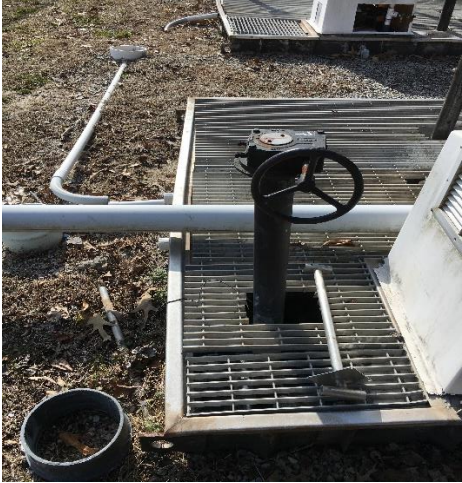
| <p>Many of the filtration valves are difficult to operate or move too freely resulting in the uncertainty of proper operation. This can result in improper filtration or backwash operation.</p> | |

- a) It is recommended to replace “all” filtration and backwash valving for all 4 filter systems. This includes the addition of “isolation” valves as clouded blow. The isolation valves will allow bypass of a particular filter for maintenance purposes.

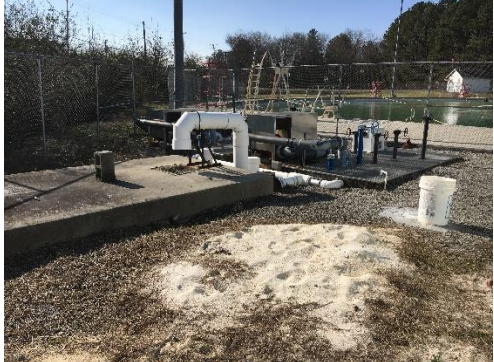
| <p>Currently the filters cannot be isolated in the event of needed maintenance due to the lack of isolation valves.</p> | |

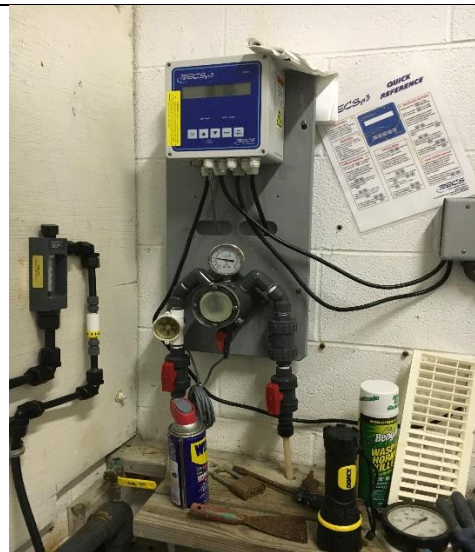
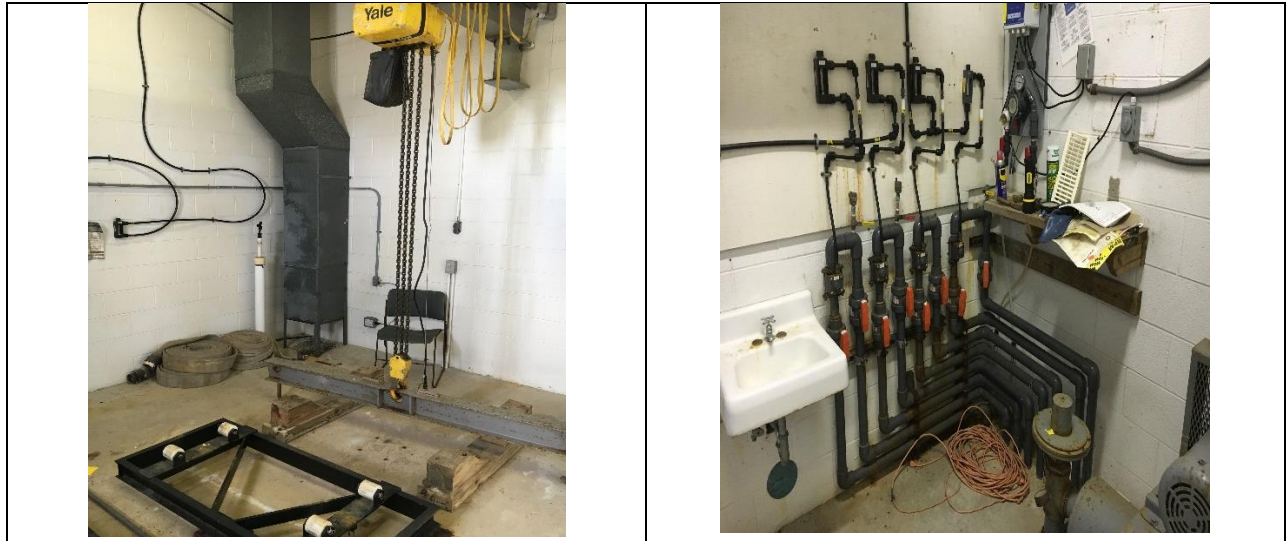
The current chemical treatment system is chlorine gas. While it is acceptable per Tennessee State Health Code, it is a very dangerous chemical and not recommended by Counsilman Hunsaker.

The chemical controller should have a “y” strainer on the intake side of the flow cell. This keeps particulate from obstructing the flow cell operation.

- a) It is highly recommended to replace the chlorine gas system with a sodium hypochlorite system. This will eliminate the potential hazards of working with such a volatile chemical creating a safer work environment for pool employees. However, I understand that the chemical cost increase would be significant.
- b) Pool staff reported a dramatic increase in chemical usage over the past 2 or three years. This can be contributed to a number of issues. However, typically we see chemical numbers jump when the pool is losing water. By testing the pool piping and gutter systems we can pinpoint a potential cause to the increased chemical usage.
- c) Install “Y” Strainers on the intake line prior to the flow cell on each chemical controller.

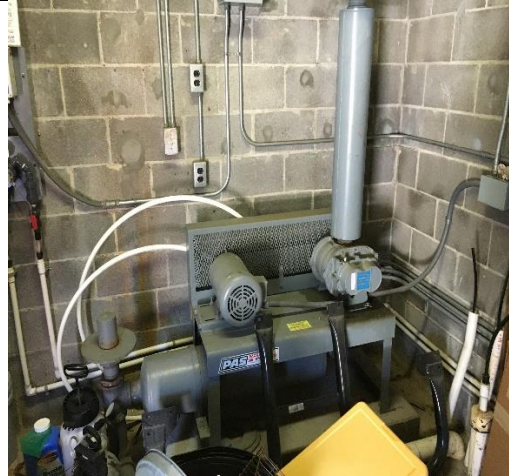
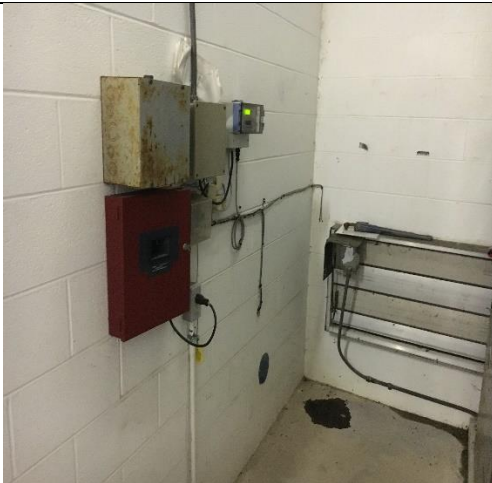
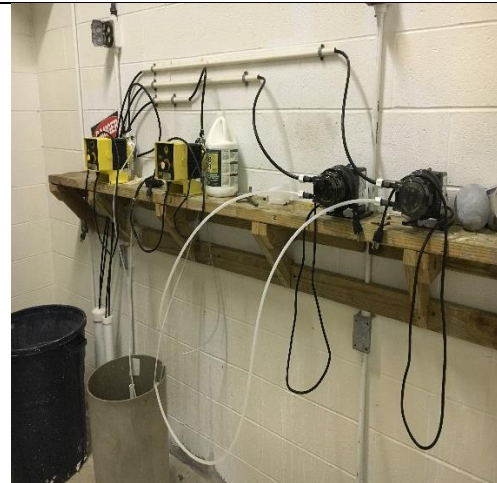
The two separate mechanical spaces house the chemical feeders, chemical controllers and the acid feed systems. Electrical panels and all metal components show minimum corrosion.

A ventilation fan was not present. However, both mechanical spaces appear to be in good condition with minimal corrosion.

- a) Exhaust fans are recommended for these rooms to remove chemical fumes and moisture.
